Shoreline and Riparian Condition Assessment

Town of Devon

December 2021

Town of Devon Summary:

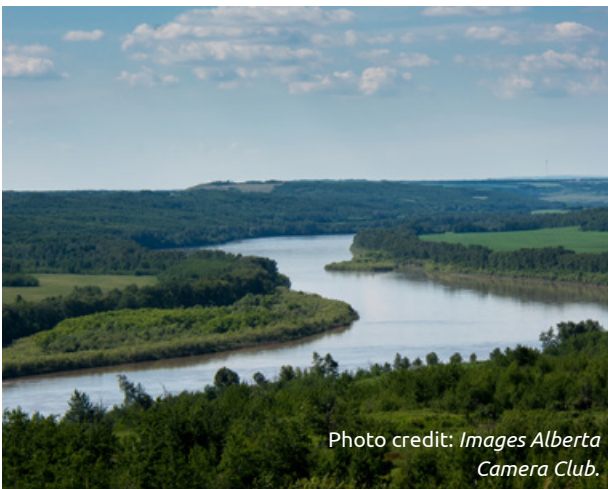
Riparian areas are transitional areas between a waterbody and the adjacent upland area.

Improve water quality by trapping sediments, filtering nutrients and pollutants, reducing aquatic plant and algal growth

Mitigate floods and droughts by storing and slowing the release of water and reducing erosion

Improve biodiversity by providing fish and wildlife habitat and cooling water temperatures

Provide aesthetically pleasing areas for recreation or cultural activities

Add economic value by increasing property values or providing areas for nature viewing

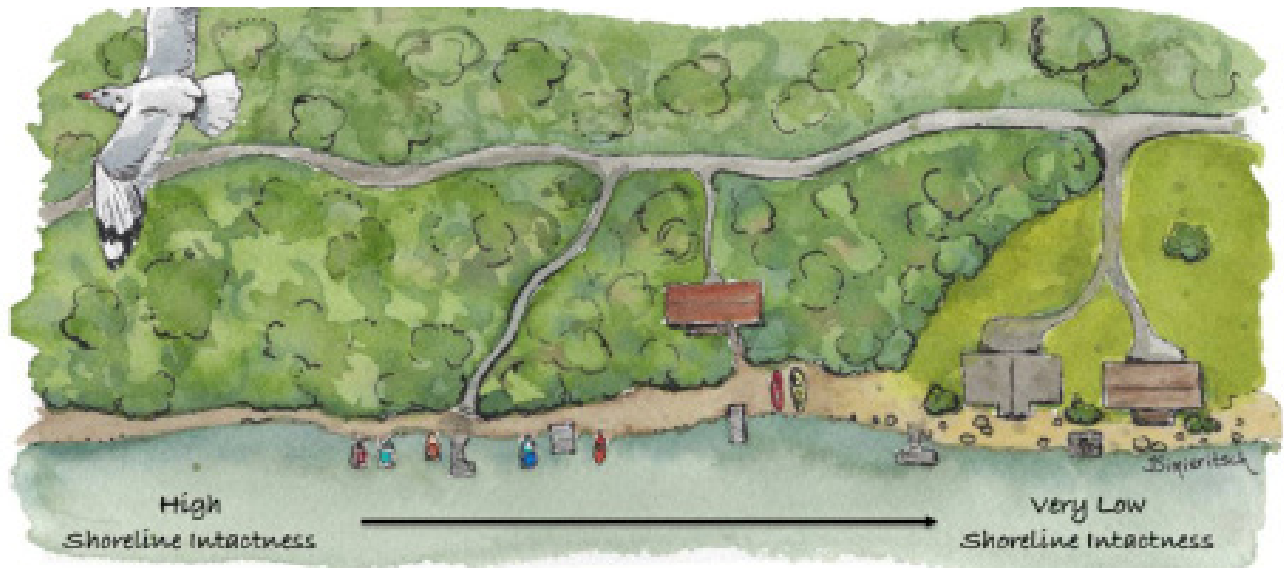
Riparian intactness is a measure of how “natural” a shoreline is. Riparian intactness measures riparian condition at a broad scale, using satellite data. This is a new method, which has been scientifically validated, to assess riparian conditions across a large area in Alberta.

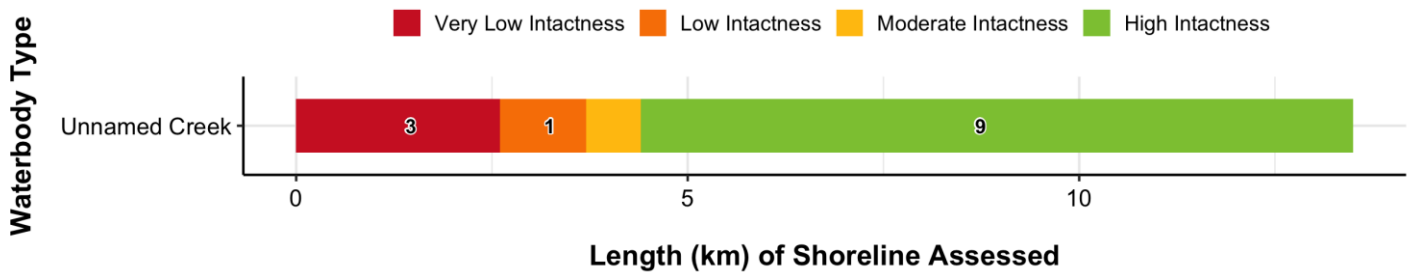
Intactness By Waterbody Type

NOTE: Numbers indicate the total length (km) of shoreline associated with each intactness category. Categories with no label contain <1 km of shoreline.

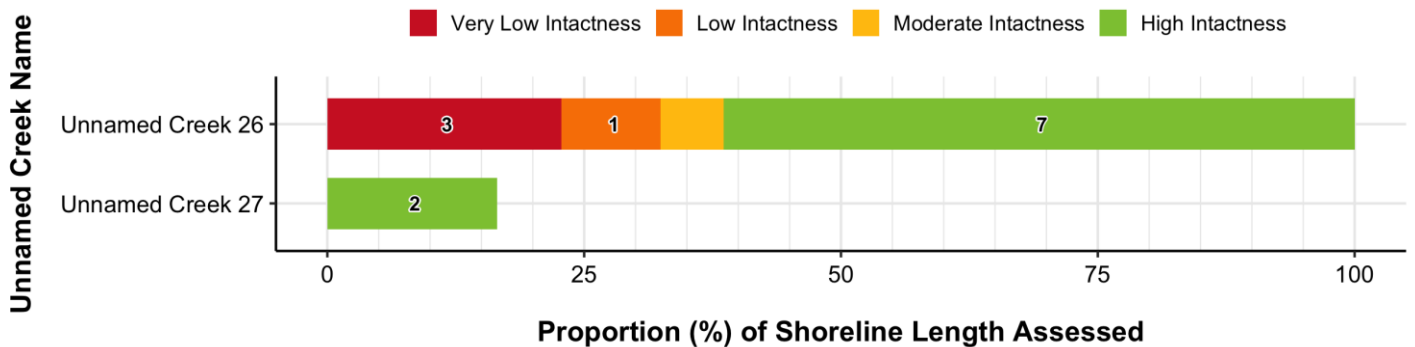
Intactness – Unnamed Creeks

NOTE: Numbers indicate the total length (km) of shoreline associated with each intactness category. Categories with no label contain <1 km of shoreline.

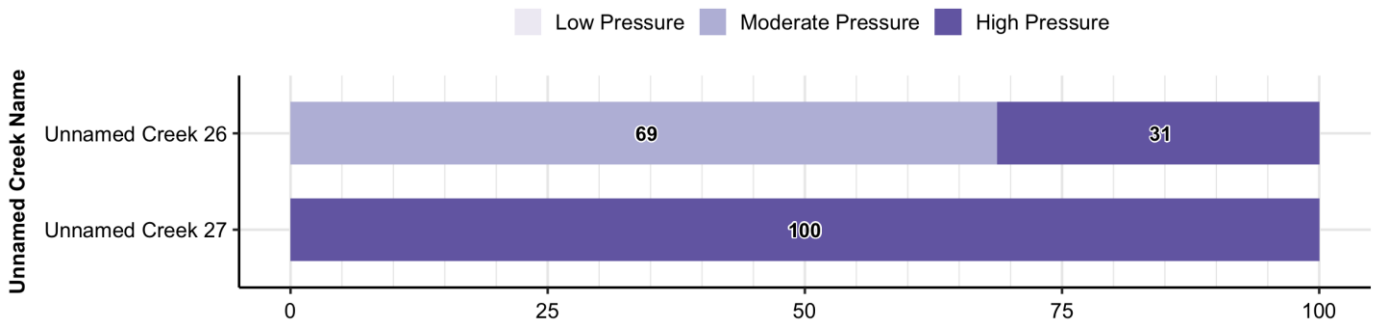
Pressure - Unnamed Creeks

NOTE: Numbers indicate the proportion (%) of shoreline associated with each pressure category.

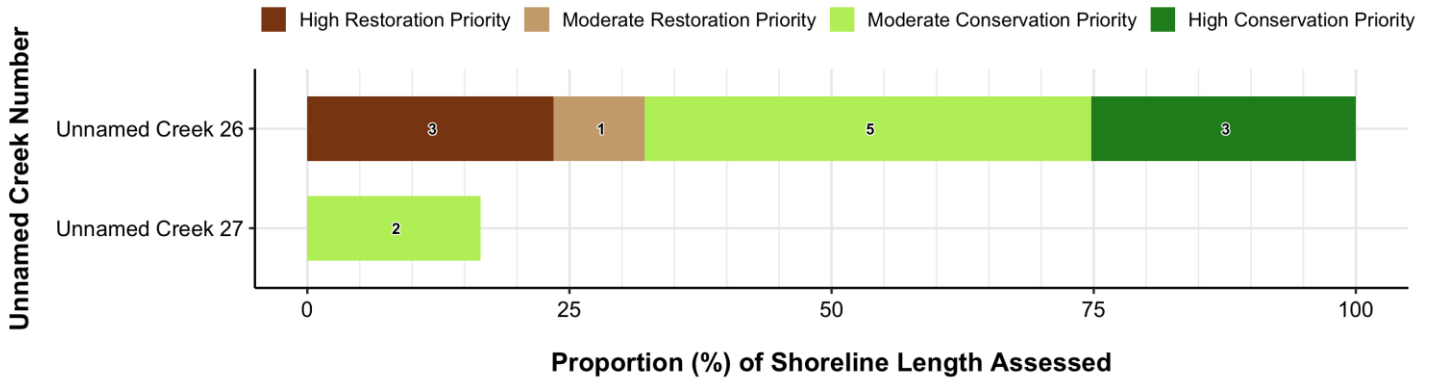
Conservation & Restoration Priority – Unnamed Creeks

NOTE: Numbers indicate the total length (km) of shoreline associated with each prioritization category.
